Investigation of Exhaust Valve Failure in Heavy - duty Diesel Engine

Nurten VARDAR^{1*}, Ahmet EKERİM²

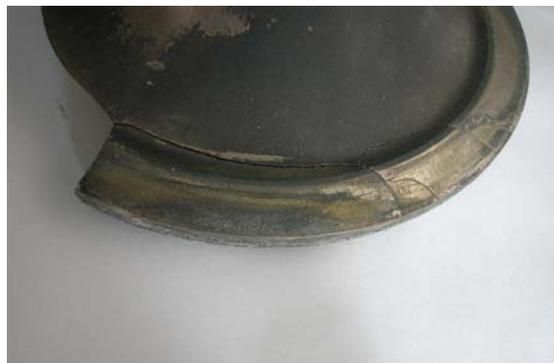
The macro cracks on the seating area of the damaged valve are shown in Figure 1. As can be seen from the figure the macro cracks have been formed after the micro cracks get to a critical length through the impact area of the valve which is illustrated in Figure 2. These cracks are attributed to the mechanical stress resulting from the closing of the valve. Figure 3 shows a different view of the valve. It was reported that the valve had catastrophically failed and parts of the table had dropped down in to the cylinder.

Figure 1. Cracks on table of failed exhaust valve.

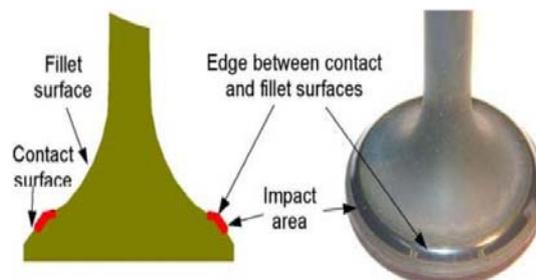
Figure 2. Location of impact area on the exhaust valve.

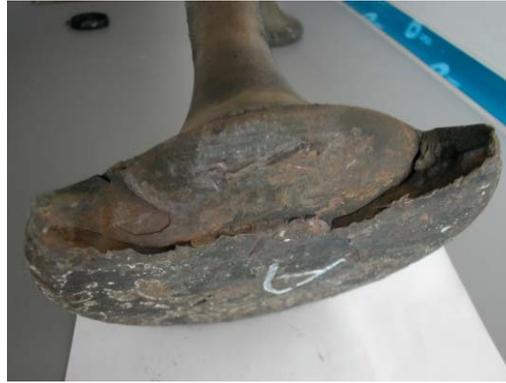
Figure 3. Catastrophic failure on the valve table.

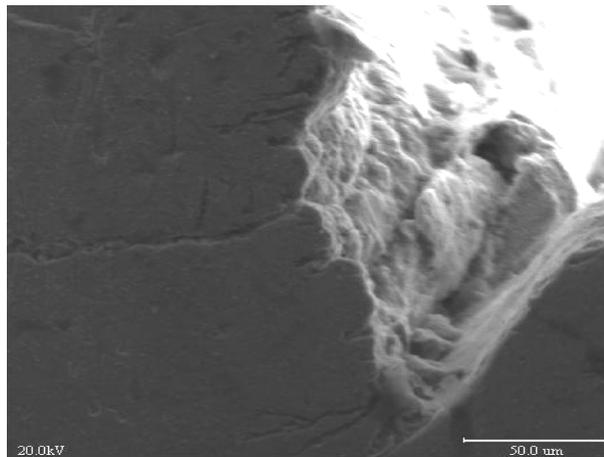
The SEM image taken from fracture surface is shown in Fig. 4. Fatigue striations and beach marks on the fracture surfaces do not appear. Fatigue striations and beach

marks indicate that the fracture was produced by the propagation of fatigue cracks [12]. Then, it may be concluded that the fatigue was not a possible cause of failure in the valve and the valve was broken down before its expected service life.

Figure 4. SEM image of the fracture surfaces of the failed valve.

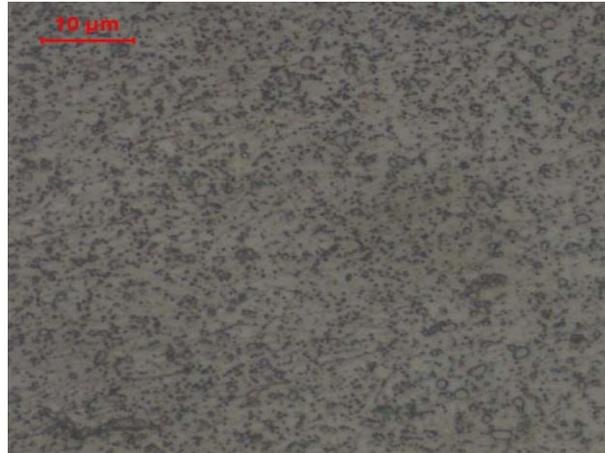
As can be seen from Figure 5 the soft annealed matrix of the valve material still presents although the material structure had decomposed with high temperature values. The microstructure consists of carbide particles precipitated in grain boundaries.

Figure 5. Microstructure of matrix.

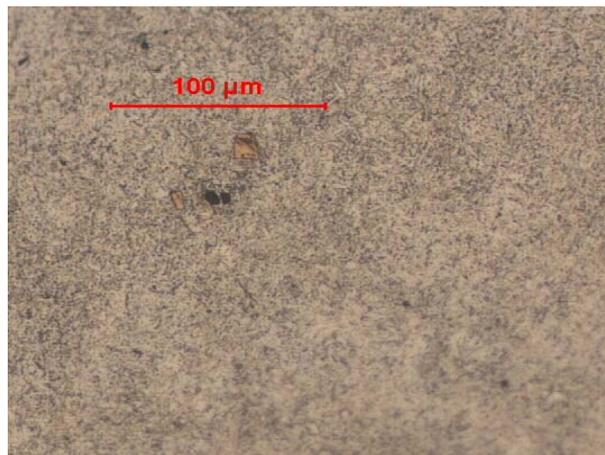
The presence of angular phases in stem and table of the failed valve was observed. The angular phases present in

both stem and table of the failed valve are shown in Figure 6 and Figure 7 respectively. The angular phases, most of which have fairly smooth square shapes, were also observed by scanning electron microscopy. Figure 8 shows an SEM image of an angular phase. Figure 9 shows the results of the EDX analysis, which was performed in order to analyse the angular phase seen in Figure 8.

Figure 6. Microstructure of valve stem.

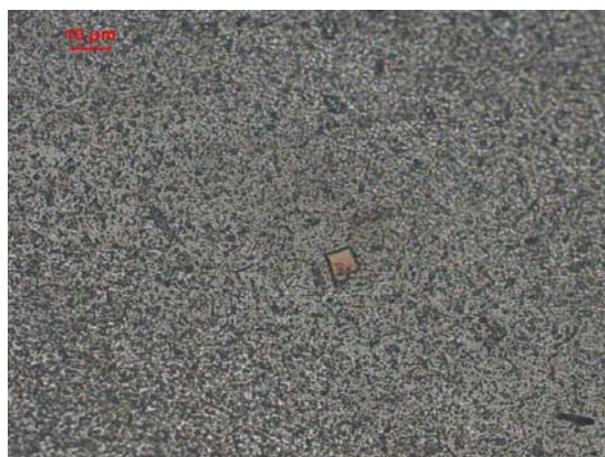
Figure 7. Microstructure of valve table.

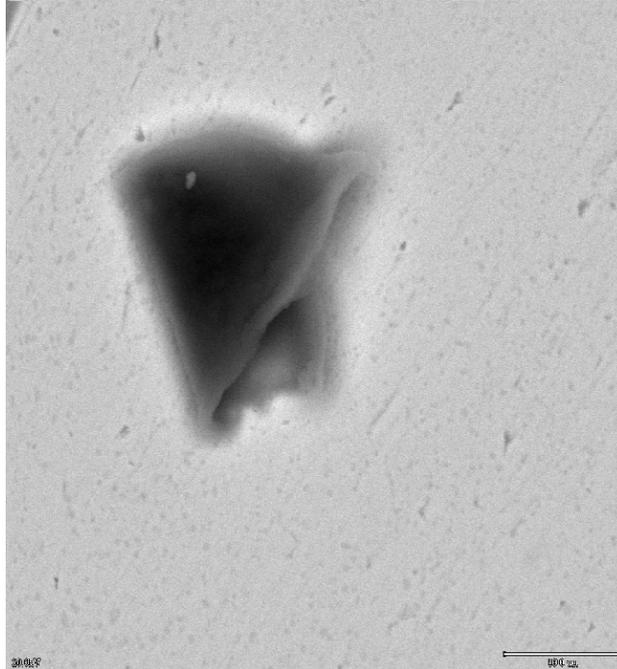
Figure 8. SEM image of angular phase.

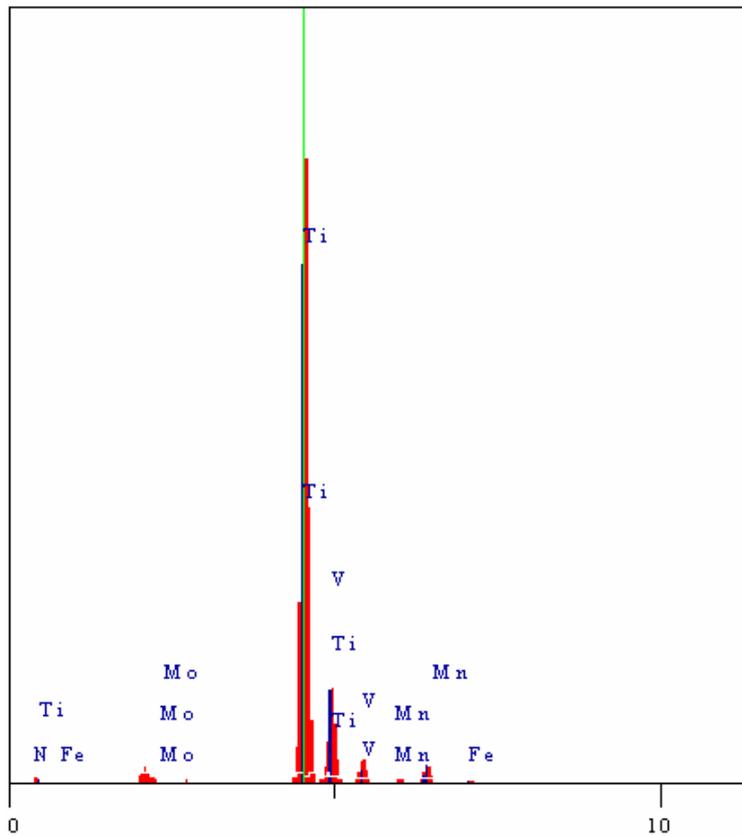
According to the results of the EDX analyse the angular phases are titanium, which may be due to not maintaining an adequate alloying temperature value during addition of titanium and therefore causing titanium not to dissolve in

Figure 9. EDS analyse results of the point shown in Figure 8.

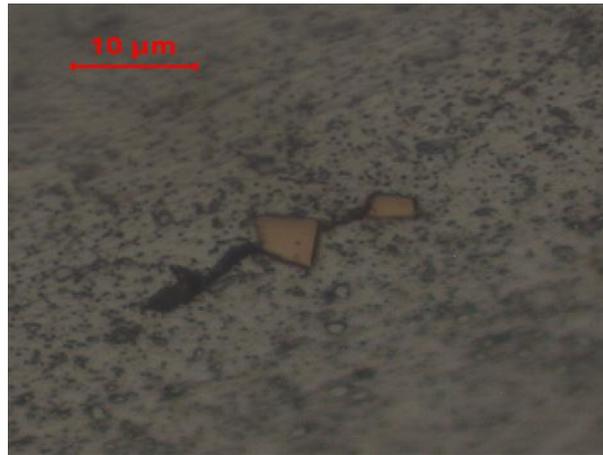
material structure. The angular phases had caused crack initiation in the material structure as shown in Figure 10.

Figure 10. Image of crack initiation in valve table.

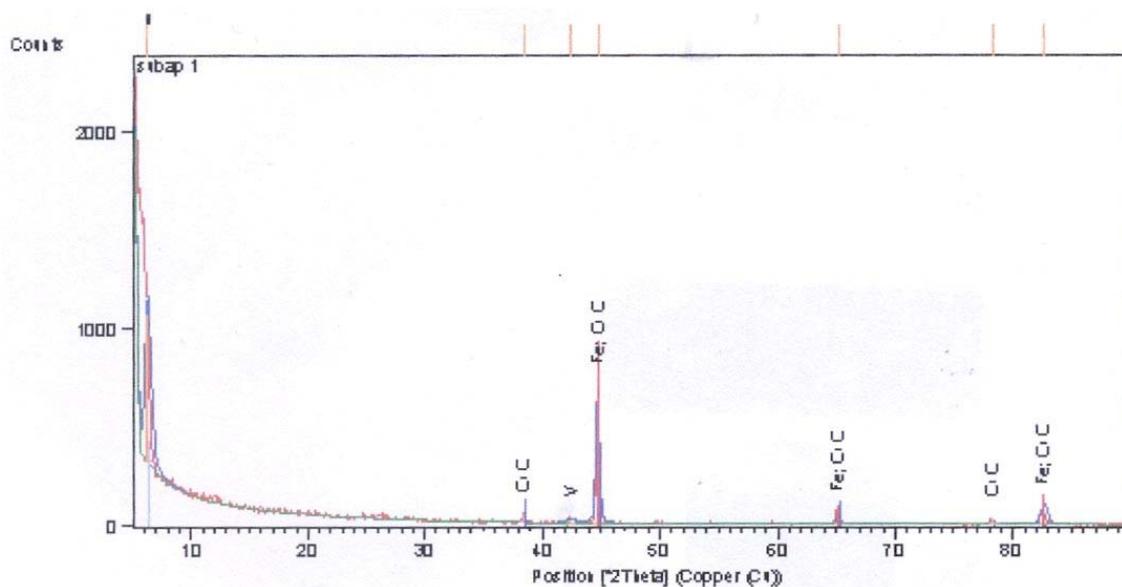
As can be seen from the Figure 11 chromium carbide and vanadium were detected on the surfaces of the failed valve. The presence of the chromium carbide is almost

unavoidable in high ambient temperature. The presence of the vanadium indicates the existence of the fuel-borne vanadate compounds which are causes of the hot corrosion on the surfaces of the valve [5].

Figure 11. XRF analyse results.
